# Managing Threats to the Tankerhoosen River Watershed: A Plan for Protecting Its Water Quality and Ecological Health

February 26, 2009

# Purpose of Tonight's Meeting

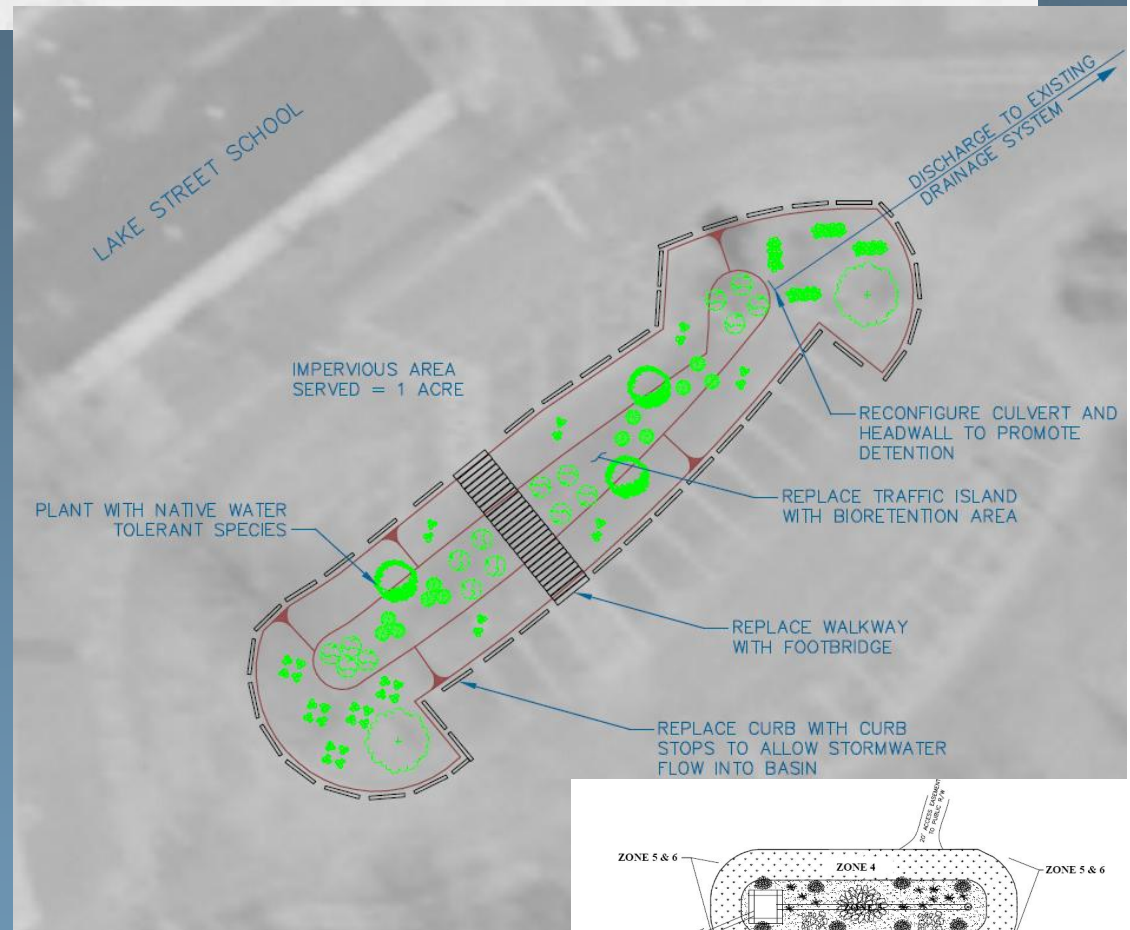
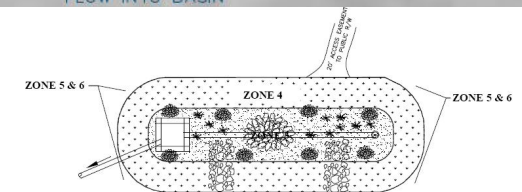
PLAN

- Convert existing traffic island to bioretention/rain garden
- Ideal demonstration project
- Cost estimated at \$94,000

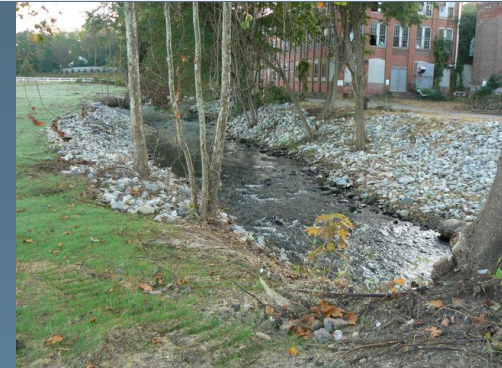
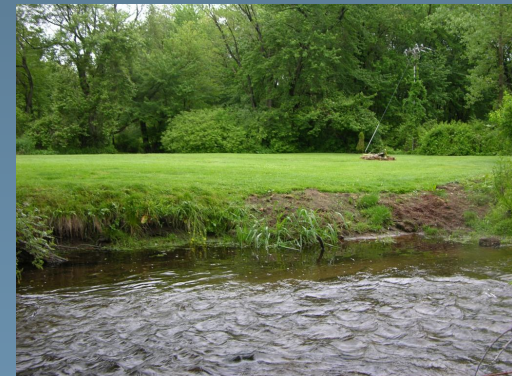
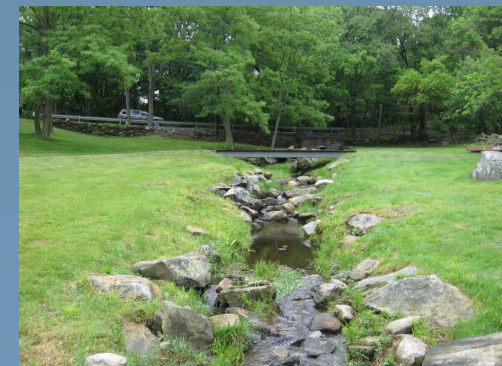
# Riparian Buffer Restoration

- Stream buffer encroachments common
- Residential and commercial lawns, historical mill development
- 10 to 15 candidate sites identified
  - *Install new buffers*
  - *Widen existing buffer*
  - *Invasive species removal*
  - *Tree planting/reforestation*
- Sites need further evaluation

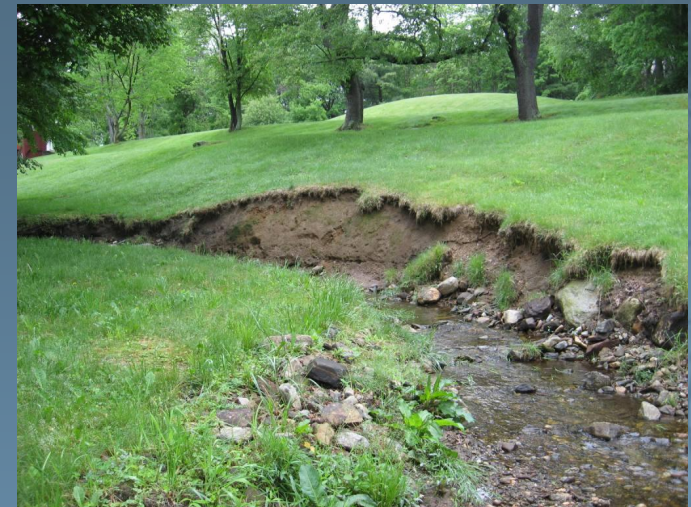
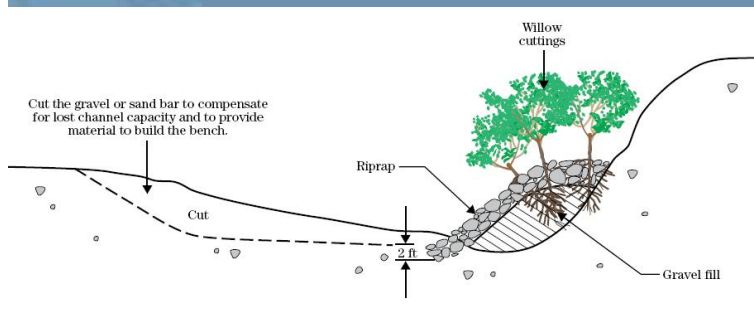
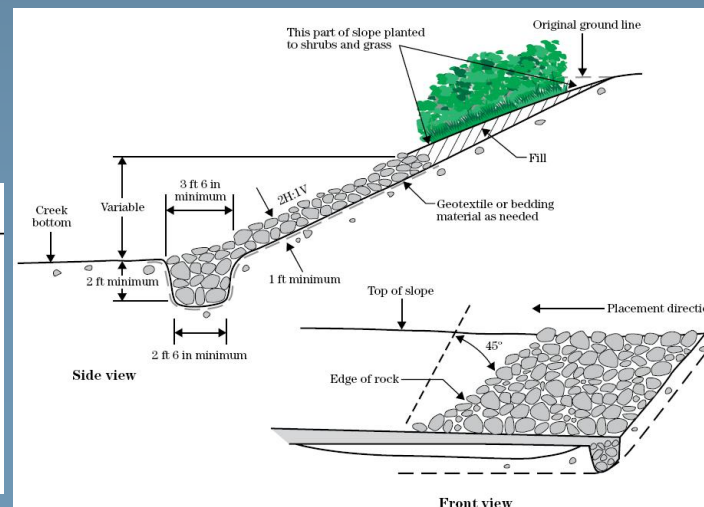
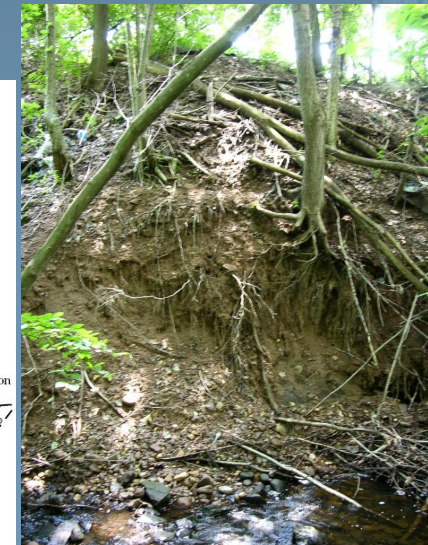
# Stream Bank Restoration

- Isolated areas of moderate to severe bank erosion
- 15 priority bank restoration sites identified
- Typical restoration techniques:
  - *Slope stabilization*
  - *Toe protection*
  - *Bioengineering*
